**BERKELEY CITY COUNCIL FACILITIES, INFRASTRUCTURE,
TRANSPORTATION, ENVIRONMENT & SUSTAINABILITY COMMITTEE
SPECIAL MEETING**

**Wednesday, September 3, 2025
2:00 PM**

2. Recreation and Community Facility Improvement Measures

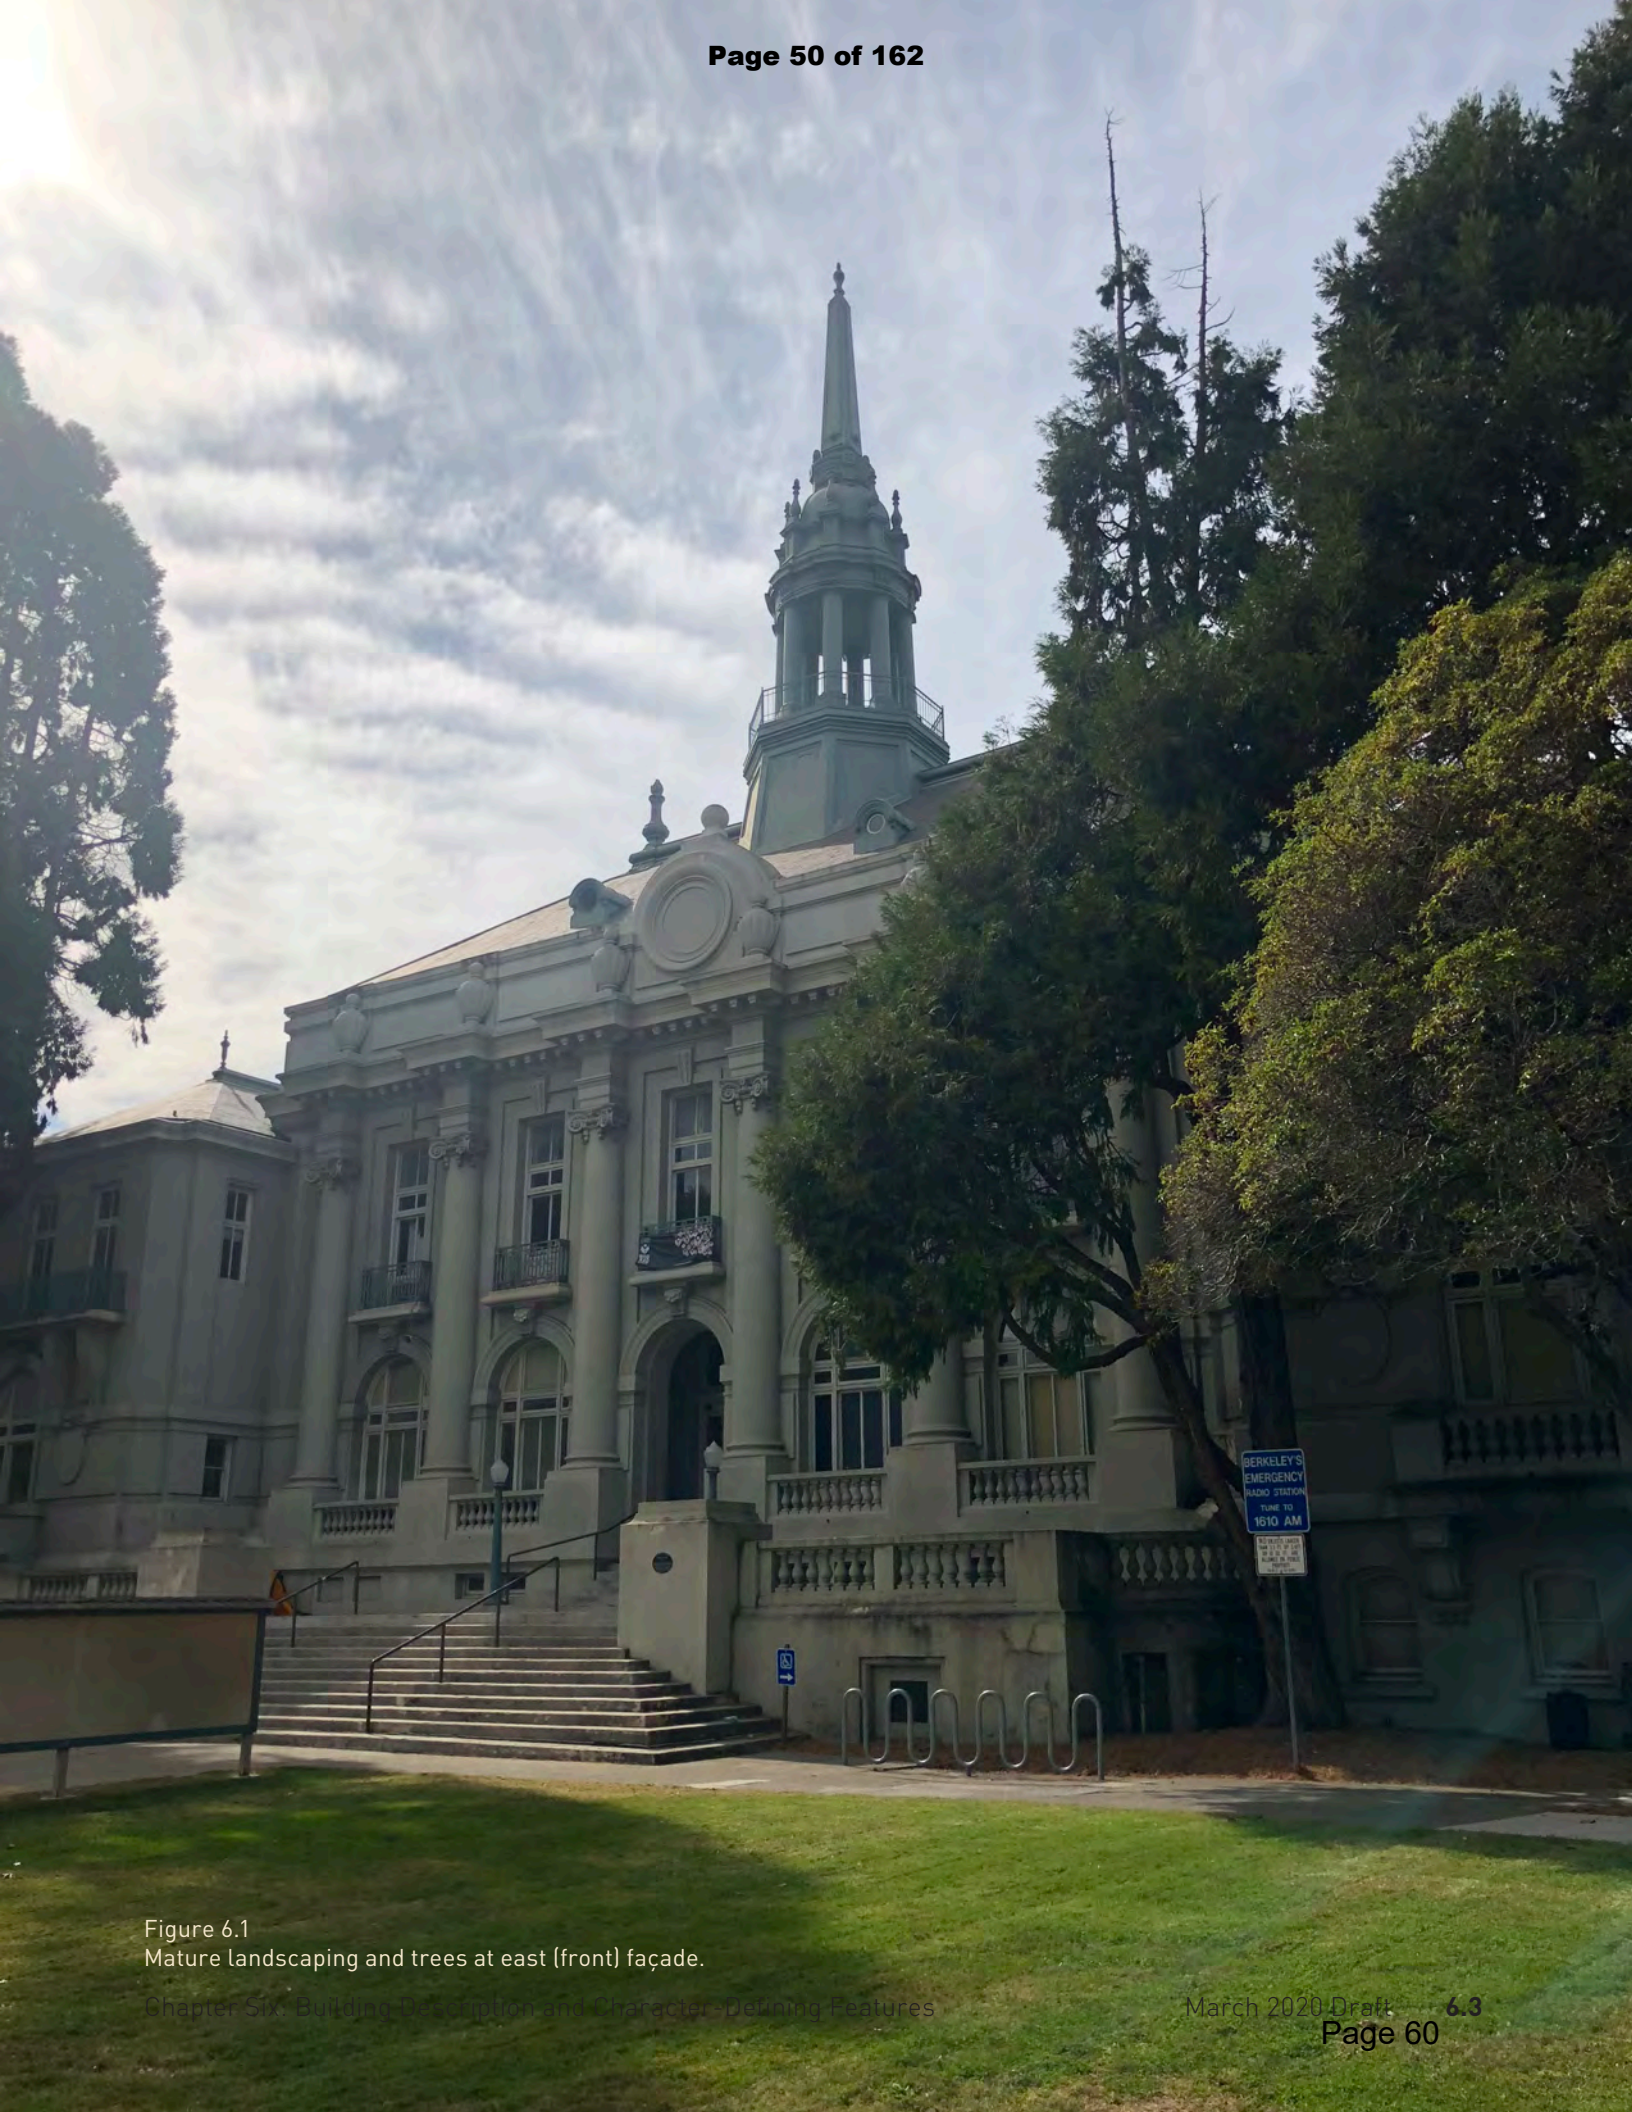
Figure 6.1  
Mature landscaping and trees at east (front) façade.

CITY HALL, OR THE MAUELLE SHIREK BUILDING, is situated to the west of Civic Center Park facing Martin Luther King, Jr. Way (formerly Grove Street) in downtown Berkeley. It is set back from the street and symmetrical lawn panels and paved paths give prominence to a set of stairs rising to the building entry (*Figure 6.1*).

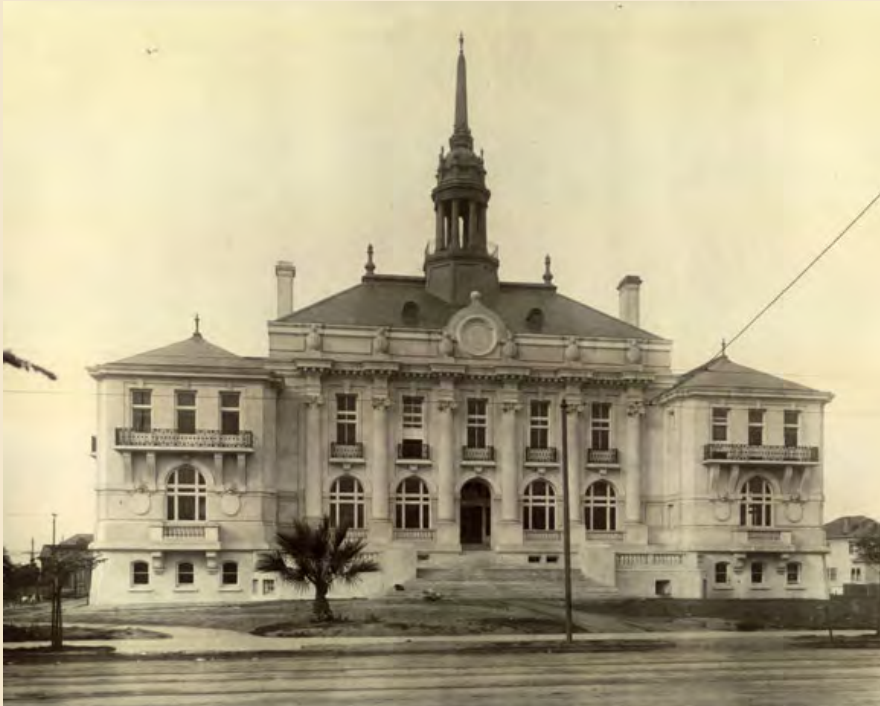
Figure 6.2  
Historic photograph c. 1910 BAHA.

City Hall is set back from Martin Luther King, Jr. Way, and originally had very few plantings near the building. Early photographs show to small palms and a lawn area. Eventually, some low plantings were placed at the building base and taller trees to the north and south sides of a lawn. (*Figure 6.2*). The building rose well above adjacent trees with the exception of the redwoods to its southeast. Columnar incense cedars established a regular rhythm at the two wings of the building to the north and south; by the 1950s the cedars reached to the lower edge of the third story windows. They are planted very close to the building.

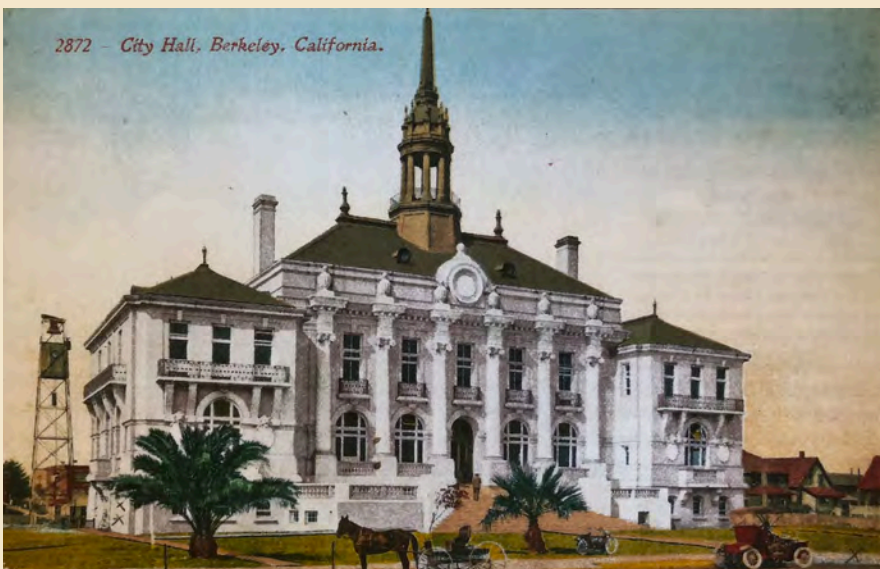
Figure 6.3  
Historic postcard c. 1910 showing well-tended planting areas around City Hall.

Understory planting is sparse consisting of a few shrubs that have been limbed-up to provide for sightlines. The surface of planting areas, including those with no planting, is bark mulch. Historic photos show more diverse and well-tended planting areas that include shrubs, perennials and ground covers (Figure 6.3).

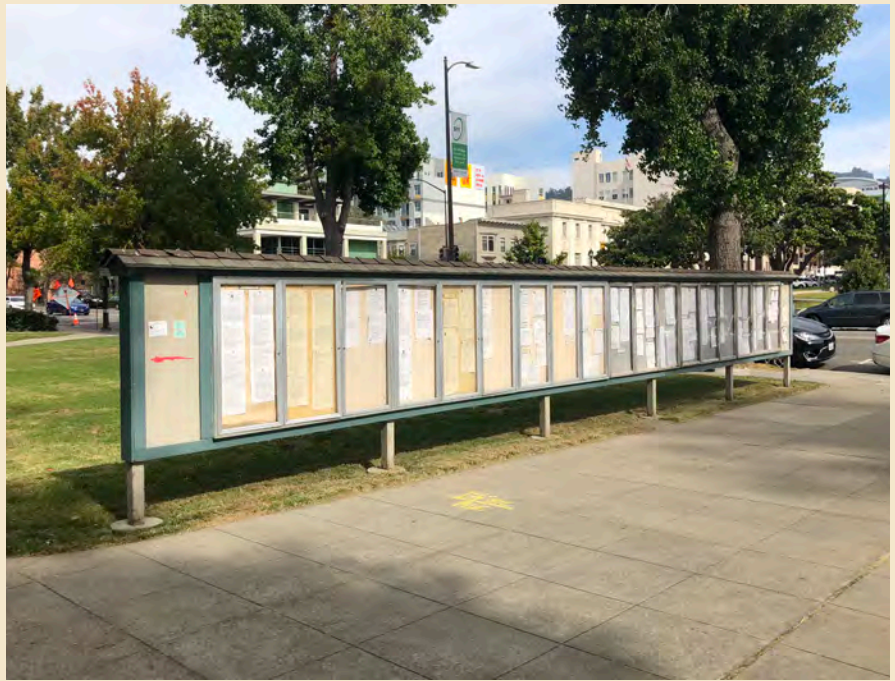
Figure 6.4  
43-foot long sign board with  
glass-fronted cabinets located in  
front of the building.

There is a plethora of small-scaled features in the landscape in front of City Hall. A flagpole, also visible in historic photographs, sits to the southeast of the building. At the building front there is a 43-foot long sign board with glass-fronted sign cabinets mounted on a frame with a 16-inch wide hipped roof running its length (Figure 6.4). These house notices and agendas of meetings of City commissions etc. A stone Japanese lantern standing approximately seven-feet high is sited under the redwoods. At the southeast corner of building the landscape is a diverse collection of small-scale elements, memorials, civic art, and a survey marker including the following:

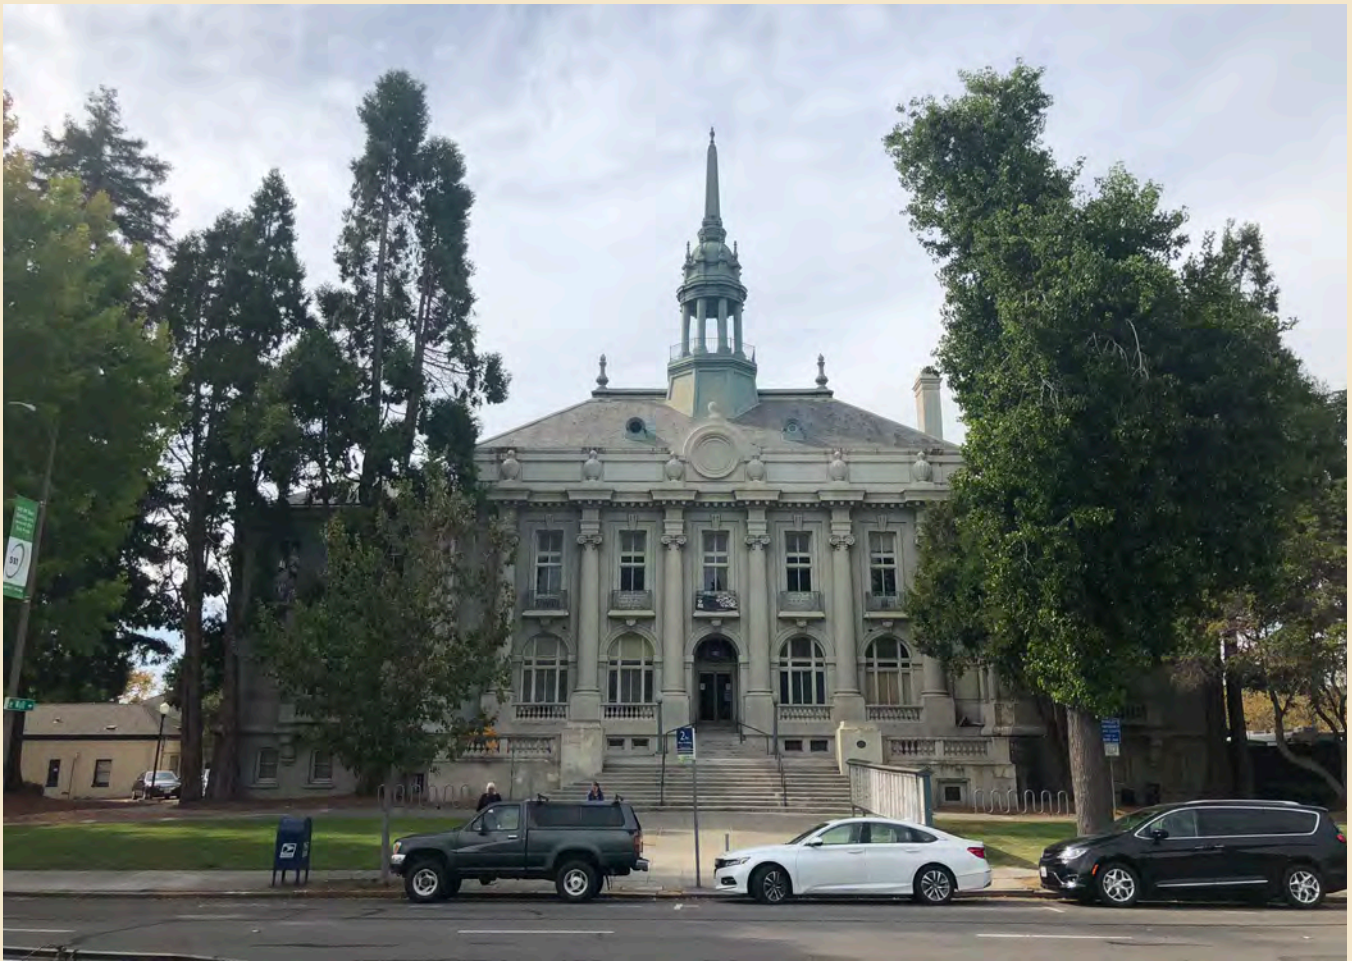
Figure 6.5  
East (front) façade.

BERKELEY CITY HALL IS AN EXAMPLE of Beaux-Arts-inspired Classical architecture and employs elements from Greek and Roman sources, as well as French Neo-Classicism (*Figure 6.5*). The building faces Martin Luther King Jr. Way and Martin Luther King Jr. Civic Center Park. The center of the facade and Civic Center Park are on axis. The building is two stories with an unfinished attic level and is above a raised basement (at grade). The main level, or piano nobile, is accessed via an exterior stair. It has a roughly rectangular footprint that measures 180-feet wide and 120-feet deep. The walls are reinforced concrete clad in cement plaster, which have been painted a light gray color. The exterior wall corners are chamfered.

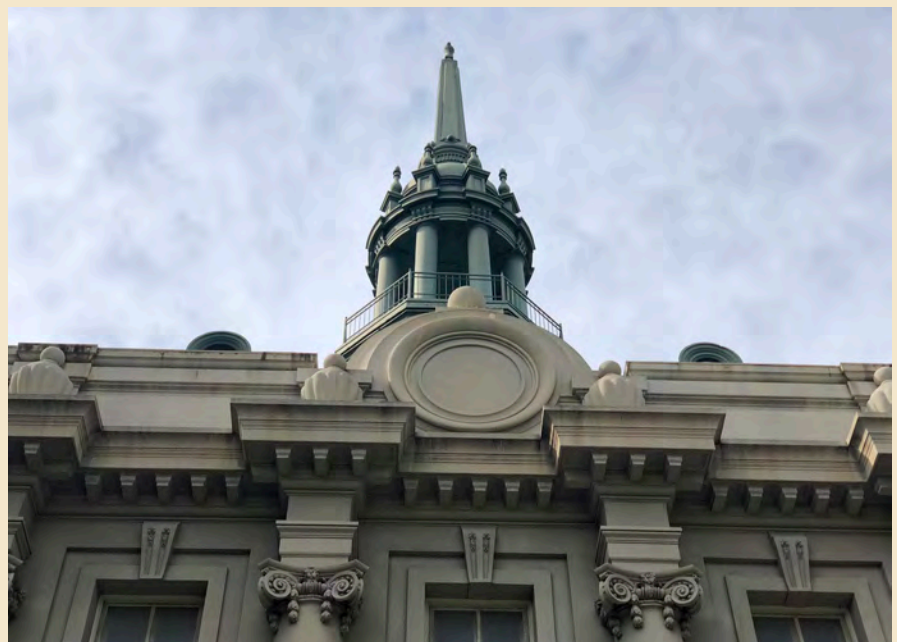
Figure 6.6  
The octagonal cupola and spire are  
made of sheet metal on a wood frame.

At the center of the main roof, there is a lantern-style, 60-foot, octagonal cupola and spire composed of painted sheet metal on a wood frame (*Figure 6.6*). The circular cupola sits on an octagonal base and is surrounded by a metal railing. The cupola features eight columns without capitals, an entablature, and eight finials on pedestals surrounding a domed roof. A four-sided spire with finial

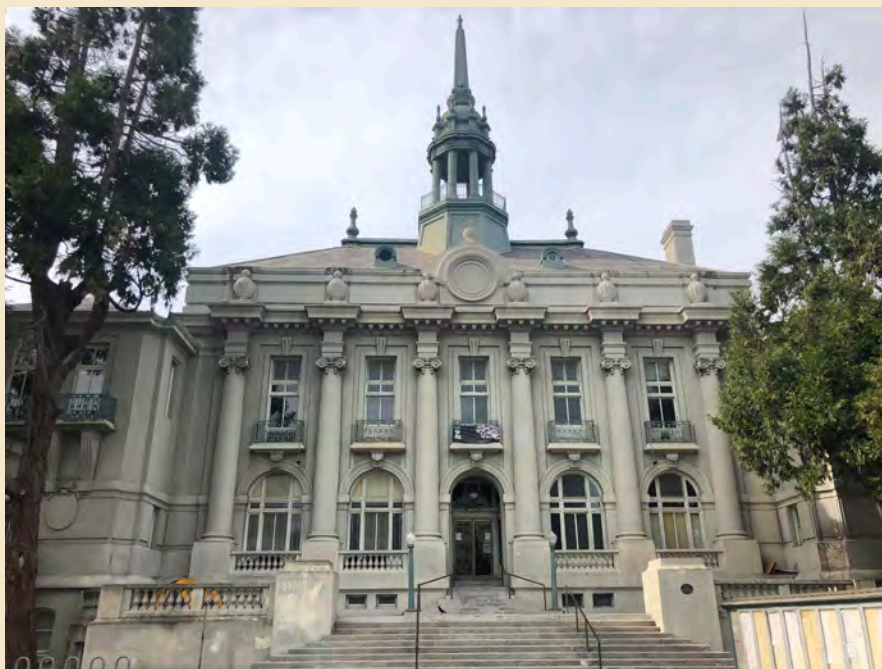
Figure 6.7  
The center section of the east (front) façade's three-part composition.

The east (front) façade is symmetrical and is a three-part composition: a recessed center section with projecting south and north wings (*Figure 6.7*). Each wing is about 31-feet wide. The cornice of the recessed center section is taller than those of the wings and is more elaborately ornamented. The cornice is composed of block modillions and an entablature, which steps out above each column; each projection is topped by an urn finial at the frieze. At the center of the cornice, there is a bull's eye medallion surmounted by a ball finial. This was the intended location of a clock that was never installed.

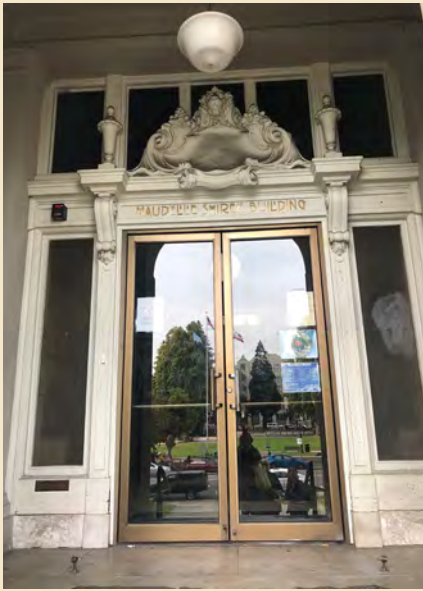
Figure 6.8  
Original main entrance surround  
with modern replacement doors.

feature semicircular-arched openings with pronounced springers and ancon and swag keystones. The center arch frames the main entrance vestibule, and the other arches frame the first floor windows, which are divided into ten lights. The entrance vestibule leads to a pair of gold-toned, aluminum, glazed doors (later alteration). Sidelights and a five-light transom frame the entrance. A simplified entablature that divides the doors from the transom above is flanked by ancons, or brackets, supporting finials. Gilded letters that spell “Maudelle Shirek Building” are located in the frieze (later addition). Between the finials there is a wide plaster shield topped by a stylized lion head bordered by cornucopias and arabesques. A simple light fixture with milk glass globe hangs from the entrance vestibule ceiling (Figure 6.8).

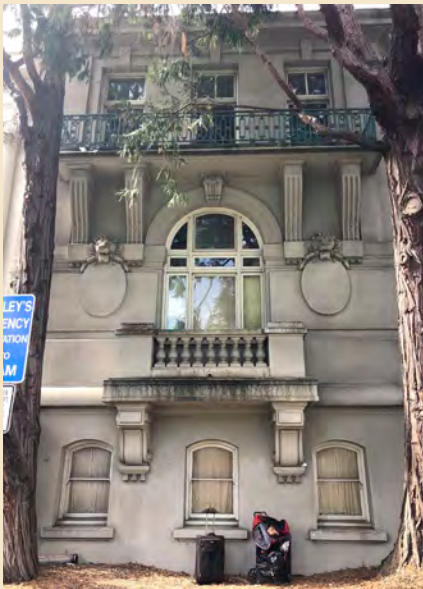
Figure 6.9  
East (front) façade of the south wing.

At the basement level, the south wing's east façade has three segmentally arched, double-hung, wood windows (Figure 6.9). At the first floor, there is a semicircular-arched, nine-part window with ancon and swag keystone. Below the window, there is a concrete balcony, which is supported by oversized brackets with guttae and is surrounded by a concrete balustrade. On either side of the balcony, there are sculpted lion heads grasping garlands and ribbons above plain oval medallions. At the second floor, there are three two-light windows with two-light transoms surrounded by rectangular molding with keystones. Second floor windows in the south wing are not original, but they are in their original locations. A continuous balcony supported by pairs of oversized fluted consoles with bell flowers and guttae is located beneath the windows. Ornamental wrought-iron railings surround the balcony. The north wing's east façade is identical to that of the south.

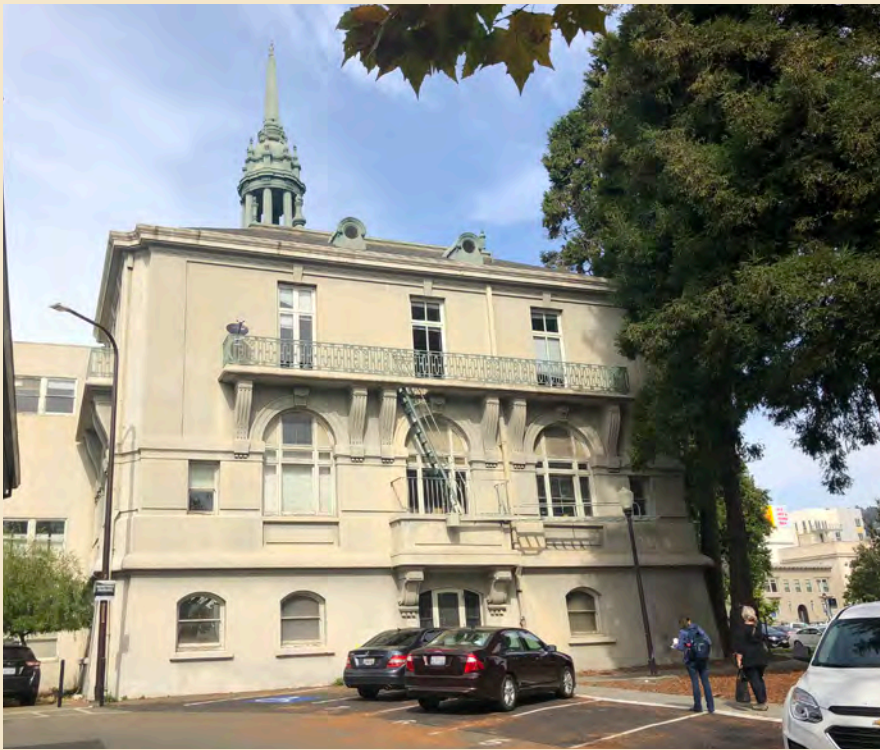
Figure 6.10  
South (side) façade.

The south facade continues many of the architectural elements found on the south wing's east façade (Figure 6.10). There are three segmentally arched openings at the basement level. The center is a larger opening, housing the original glazed, arched wood door and replacement aluminum three-light sidelights. The outer two openings have double-hung, wood windows. At the first floor, there are three semicircular-arched, nine-part windows with ancon and swag keystones. Beneath the center window, there is a balcony, which is surrounded by a solid paneled balustrade and is supported by oversized brackets with guttae. Single, wood, double-hung windows flank the arched first floor openings. A modern metal fire escape has been installed from the first floor to the second floor balconies (Figure 6.11). At the second floor, there are three two-light windows with two-light transoms surrounded by rectangular molding with keystones. These are replacement windows, but the surrounds are original. A continuous balcony supported by pairs of oversized fluted consoles with bell flowers is located beneath the windows. Ornamental wrought-iron railings surround the balcony. At the southeast chamfered corner of the building, the words "June A.D. 1908" are incised into the concrete.

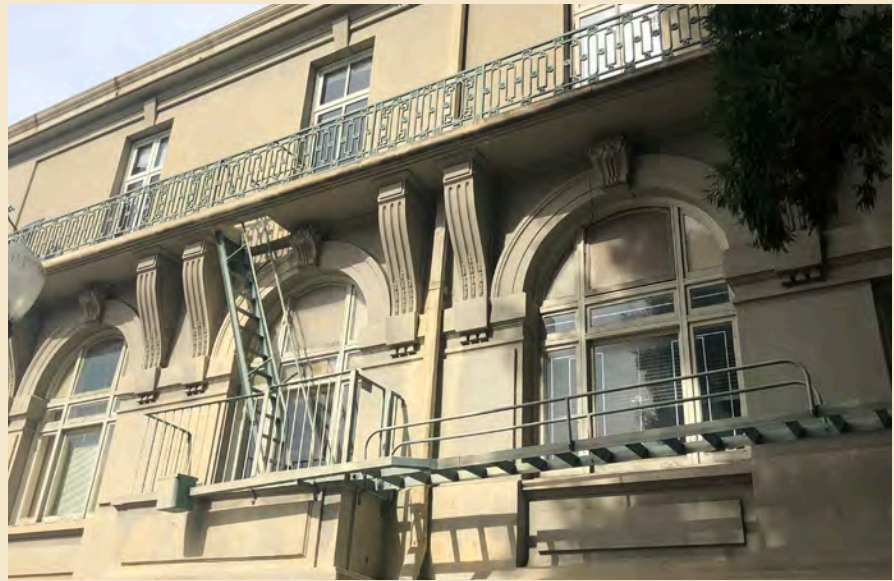
Figure 6.11  
First floor balcony and modern metal fire escape at south (side) façade.

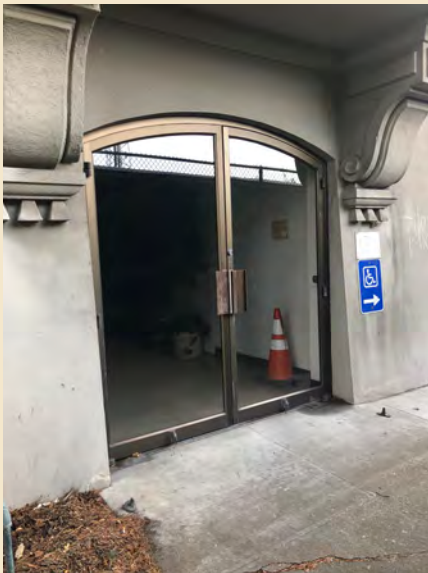
Figure 6.12  
Entrance at north (side) facade.

The north façade is identical to the south with the following exceptions: no date is inscribed at the corner and the basement entrance has a pair of modern bronzed aluminum glazed doors (*Figure 6.12*). The same type of modern, metal fire escape is present at this elevation.

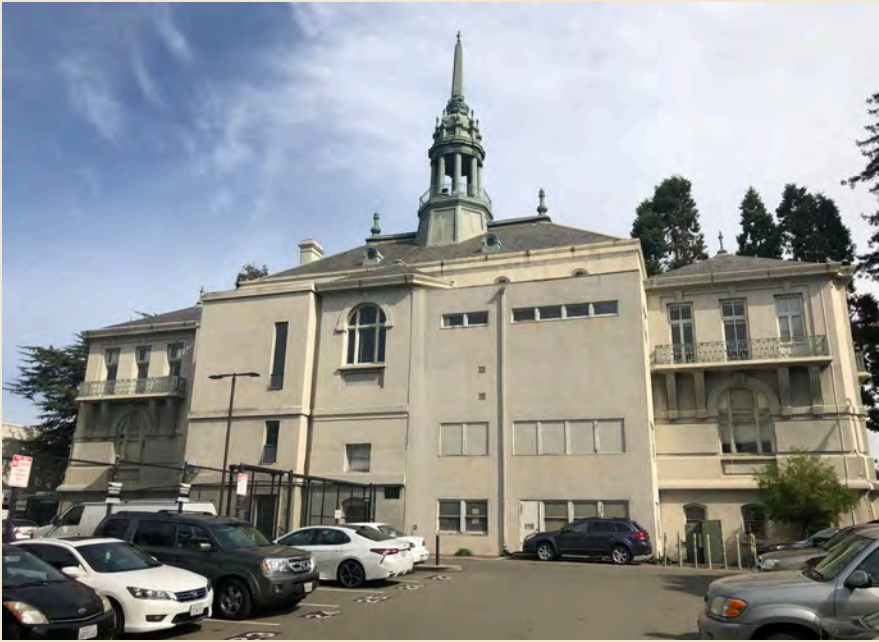
Figure 6.13  
West (rear) façade.

The west (rear) façade retains its historic appearance at the north and south wings, but the central section of this façade has been altered through several small additions (*Figure 6.13*). The two wings each have three segmentally arched, double-hung, wood windows at the basement level. At the first floor, there is a semicircular-arched, nine-part window with ancon and swag keystone. Beneath the window, there is a concrete balcony with balustrade supported by oversized brackets with guttae. At the second floor, there are three two-light windows with two-light transoms surrounded by rectangular molding with a keystone. These windows have been altered at the south wing, but are original at the north wing. At each wing a continuous balcony, supported by pairs of oversized fluted consoles with bell flowers, is located beneath the windows. Ornamental wrought-iron railings surround the balconies.

Several additions at the rear of the building have obscured the original central section of the façade. Window replacement at second floor of south wing.

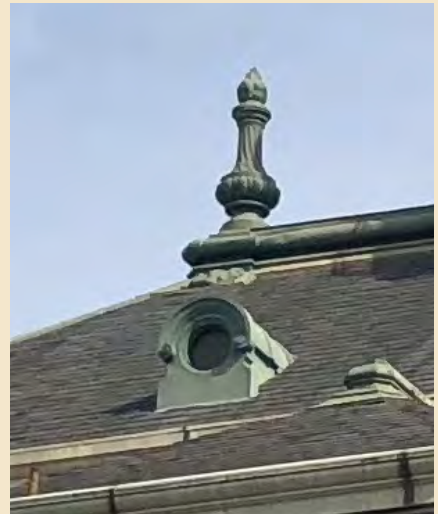
Figure 6.14  
Bull's-eye dormer at west (rear) façade.

At the center of the west elevation, the original stair hall has been added to by infilling either side of this original projecting feature. The stair hall has a segmentally arched, double-hung, wood window at the basement level. There is a double-hung wood window at the first floor level. At the second floor, there is a semicircular-arched, six-light, wood window. The arch has a keystone and pronounced spring arches. The stair hall is flanked by north and south additions; both have unornamented plaster walls. On the west façade of the projecting north addition, there are single windows on each floor: all are off center. In a section that is flush with the north wing, the addition has wood, double-hung windows with transoms on each floor. On the south addition's west façade, the basement level has a pair of double-hung, wood windows and a grouped opening consisting of a single pedestrian door and three wood, double-hung windows. On the second floor there is also a paired opening followed by a grouped opening containing four sections: both openings have been infilled. On the third floor, there is a pair of fixed, wood, clerestory windows followed by a grouped opening containing four fixed, wood, clerestory windows. On the three floors of the south elevation of the south addition, there are paired wood double-hung windows. Above the stair hall and additions on the frieze of the main block of the building, there are four bull's-eye windows. The attic level has two bull's-eye dormers similar to the front elevation (*Figure 6.14*).

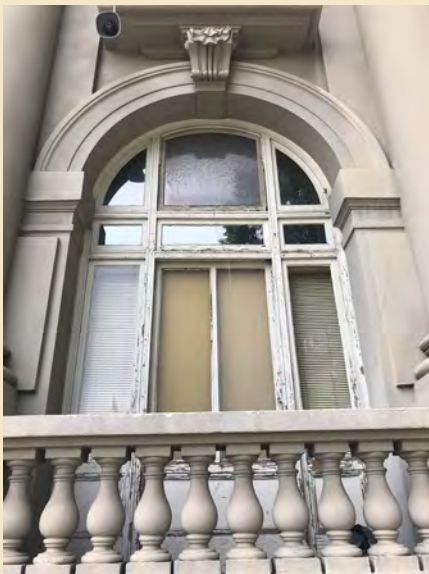
Figure 6.15  
Semicircular-arched window with pronounced springers and ancon and swag keystones are found throughout the building.

- Awning windows
- Semicircular-arched window and door openings with pronounced springers and ancon and swag keystones (*Figure 6.15*)
- Simple rectangular plaster window molding with keystones with and without bell flowers

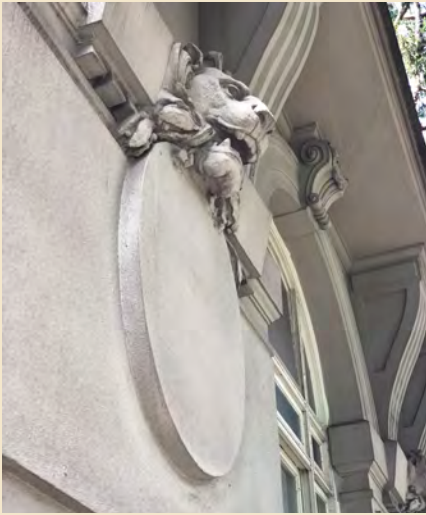
Figure 6.16  
Sculpted lion head grasping garland and ribbons above plain oval medallion at east (front) façade.

- Colossal (two-story) half columns with unfluted shafts, angled modified composite capitals, and simple pedestals
- Main entrance vestibule
- Main entrance sidelights and five-light transoms
- Simplified entablature above the main doors with ancons and finials
- Wide plaster shield with stylized lion head, cornucopias, and arabesques
- Milk-glass globe
- Grand exterior two-part concrete staircase with wraparound treads
- Terrace
- Concrete pedestals flanking the main stairway
- Fluted light posts with acorn globes
- Sculpted lion heads grasping garlands and ribbons above plain oval medallions (*Figure 6.16*)

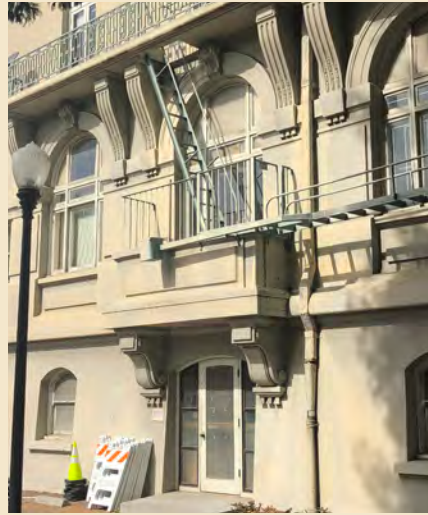
Figure 6.17  
Balcony with a solid paneled balustrade at south (side) façade.

- Symmetrical fenestration pattern
- Segmentally arched openings
- Double-hung, wood windows
- Nine-part windows
- Balcony with a solid paneled balustrade (*Figure 6.17*)
- “June A.D. 1908” incised into concrete

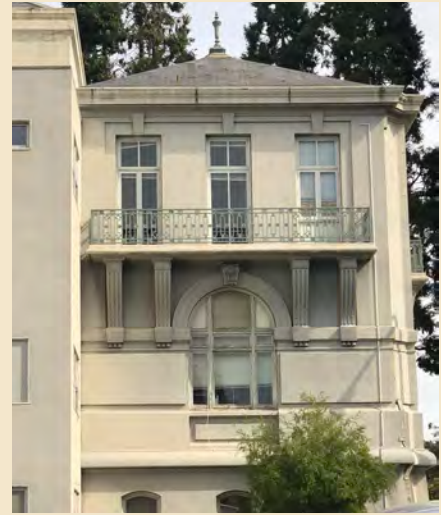
Figure 6.18  
Original nine-part windows at west (rear) façade.

- Segmentally arched, double-hung, wood windows
- Nine-part windows (*Figure 6.18*)
- Original stair hall
- Double-hung wood window
- Bull’s-eye windows

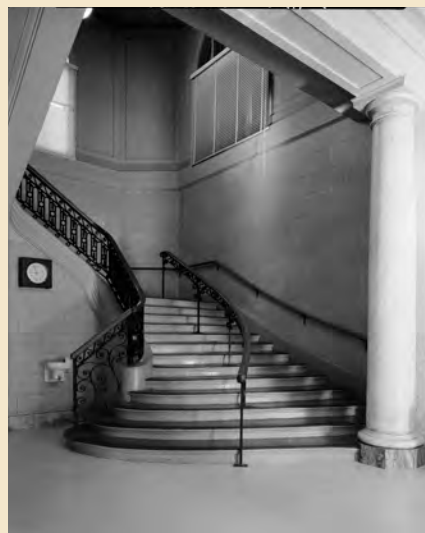
Figure 6.21  
1981 HABS photograph of the Main Stair.

The building's most decorative interior feature is the wide, u-shaped, main staircase which begins with a slight spiral at the base (Figure 6.21). The stairs are reached by passing between a pair of Doric columns painted to resemble marble and set on low bases (Figure 6.22). The risers of the wide stair undulate and the stair curves as it rises to the second floor. Originally, three, large, arched windows dramatically lit the stair, but this has been diminished by later additions on either side of this feature. The stair banister is cast iron, embellished with gold-leaf medallions, which somewhat recalls the detail of the exterior balcony railing. The railing is capped with a wood hand rail.

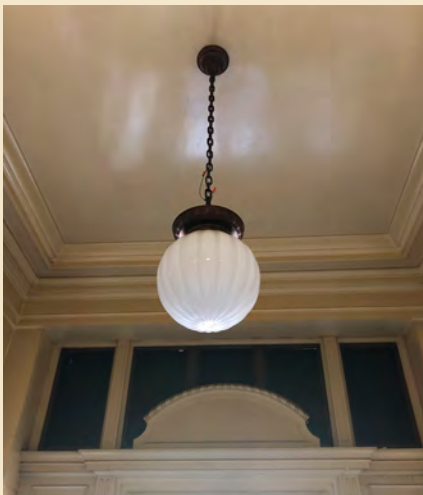
Figure 6.23  
Original pendant light fixture in the entry vestibule.

- Light grey marble dado
- Darker grey marble baseboard
- Plaster walls scored to resemble ashlar
- Plaster mouldings
- Uninterrupted corridor linking north and south wings
- Curved stair configuration
- Painted faux marble Doric columns
- Cast iron stair railing capped with wood hand rail
- Windows lighting stair
- Pendant light fixtures in entry vestibule and stairwell (*Figure 6.23*)
- Decorative painting at stairwell

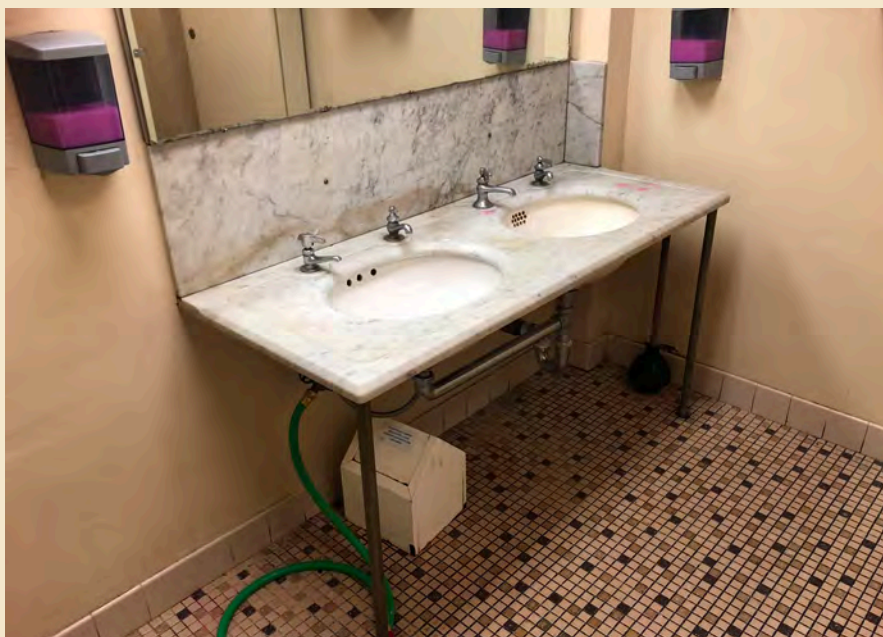
Figure 6.24  
Original double marble sink on metal pedestal legs with claw feet located in the first floor Women's Toilet Room.

The Women's Toilet Room has its original, double marble sink on metal pedestal legs with claw feet (*Figure 6.24*). The two-stall configuration is original, but the toilets have been replaced. The marble stall partitions are original. There is a patterned tile floor. The Men's Toilet Room has a single marble sink on metal pedestal legs with claw feet, similar to the women's toilet room. Partitions are not original in this room?

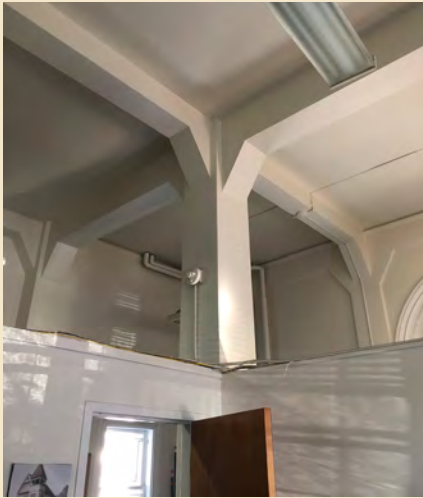
Figure 6.25  
Original structural columns and angled elements where they meet the ceiling in first floor of the south wing.

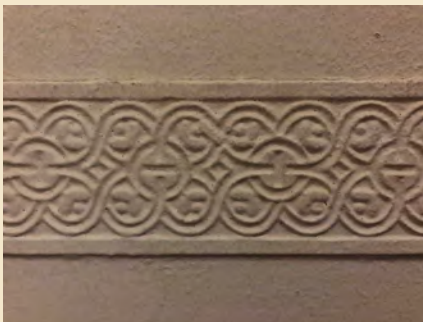
Figure 6.26  
Remnant plaster chair rail in the south wing.

- Structural columns
- Engaged pilasters at interior side of exterior walls
- Remnant wood baseboard
- Remnant plaster chair rail (Figure 6.26)
- Vaults and vault door at south wing (north wing vault door removed)
- Scored concrete flooring in vault

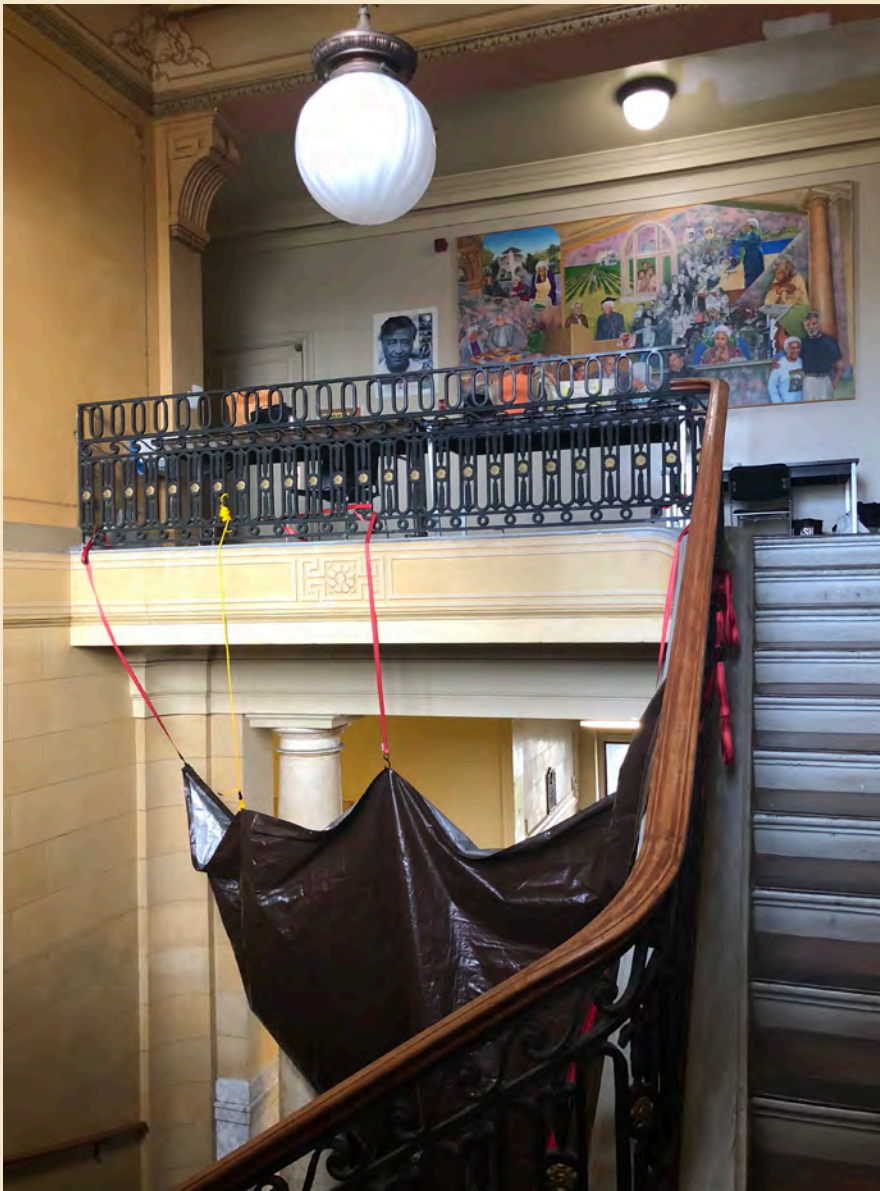
Figure 6.27  
Curved main staircase ascending to the second floor landing.

The curved main staircase ascends to the second floor landing where the second floor corridor has similar finishes to the first floor (Figure 6.27). Replacement doors mark the entry to both the north and south wings on the second floor. The City Council chamber is the primary space of the second floor. It originally had four sets of double doors off the second floor hallway. Additionally, it had a low wall, or bar, separating the public seating at the north end of the room and the area for council persons to preside. The room has a smooth, painted wood wainscoting at the lower portion with upper walls divided into panels above a chair rail. Originally plaster, the upper wall panels were infilled with acoustical fabric panels and additional wood trim, likely in the 1980s. A transom with a carved wood (or plaster?) decorative swag element appears above each door and window opening in the Council Chamber. The ceiling and flooring are not original to this room.

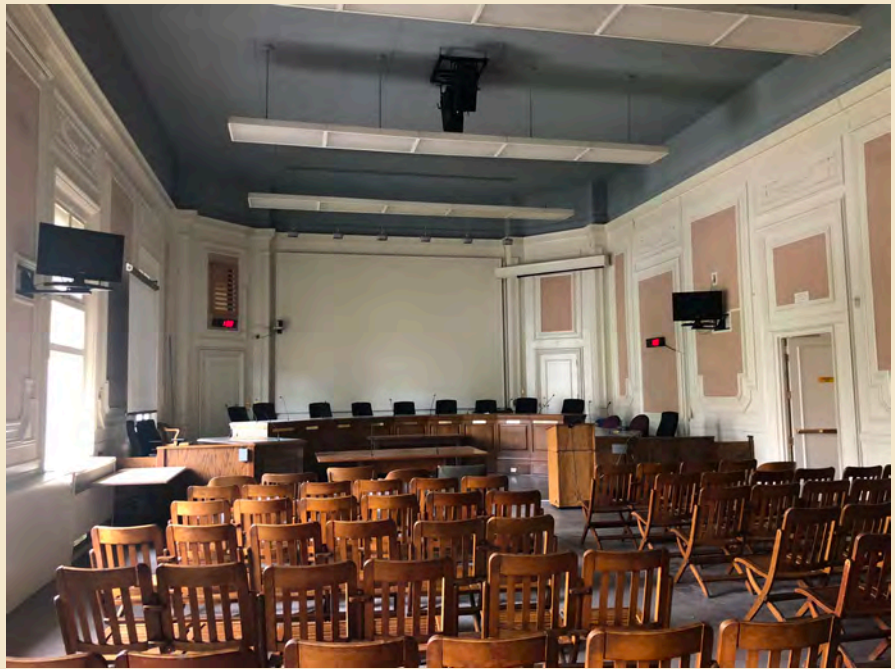
Figure 6.28  
Council chamber at the second floor.

- Council chamber floor plan
- Council chamber panel wood walls, wainscoting and decorative transoms (*Figure 6.28*)
- Uninterrupted corridor from stair to north and south wings
- Overall plan of north and south wings (interior partitions changed)
- Maudelle Shirek mural in hallway
- Second floor men's and women's restroom pedestal sinks and men's room original decorative plaster (other finishes and fixtures in these rooms are not original)

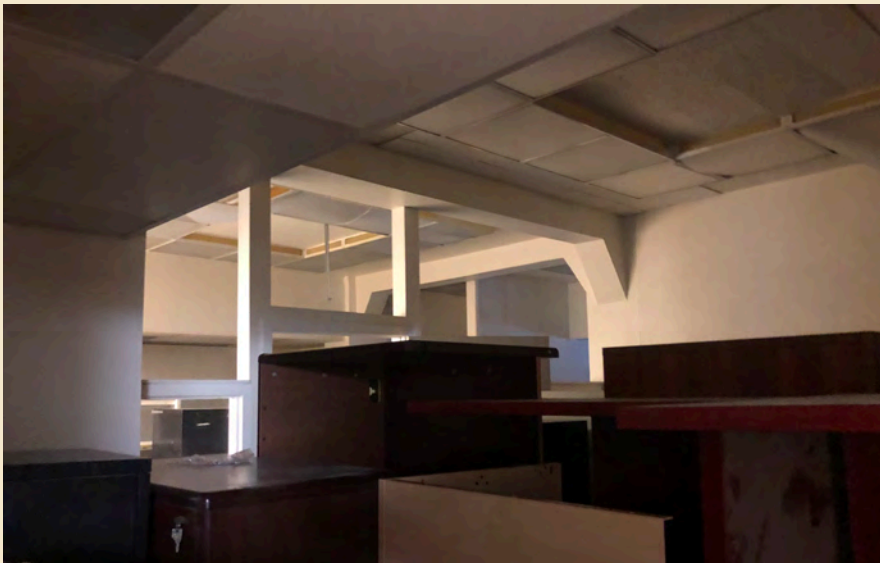
Figure 6.29  
Original structural columns and beams in the basement.

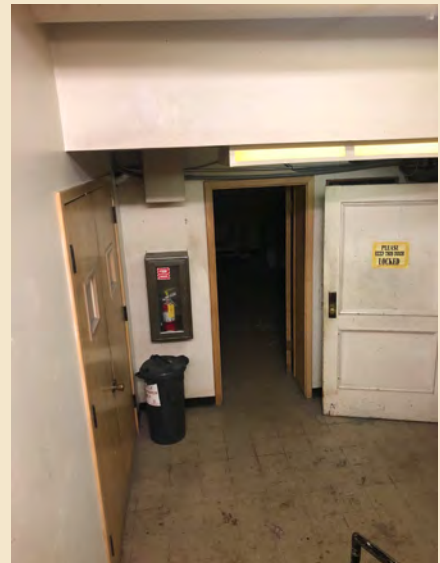
Figure 6.30  
Remnant paneled wood door in basement.

- Structural columns
- Remnant wood baseboard
- Remnant paneled wood doors (*Figure 6.30*)
- Wood and metal stairways
- Scored concrete flooring
- Segmentally arched window trim

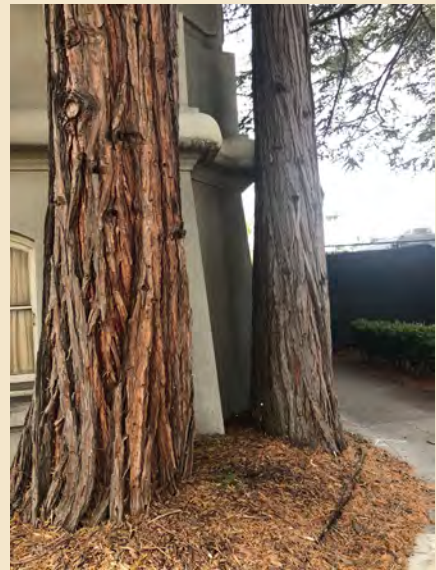
Figure 7.1

*Incense Cedars (quantity 6) are planted at an inadequate distance from the east elevation building foundation, have grown taller than originally intended, and pose a structural and physical hazard to the building. (Figure 7.1)*

The incense cedars, originally low to the ground, are now taller than the building. Their roots may be damaging the building foundations and their trunks and branches are too close to the building face. Dirt, water, tannins, rust, bio growth, and organic debris has accumulated on the building as a result.

Six Incense Cedars are planted at the east elevation are too close to the foundation and have grown larger than originally intended. Grade is in close contact with the base of the building, typical at all elevations.

Investigate the potential to lower grade at base of building. Alternatively, investigate insertion of appropriate base flashing at base of wall.

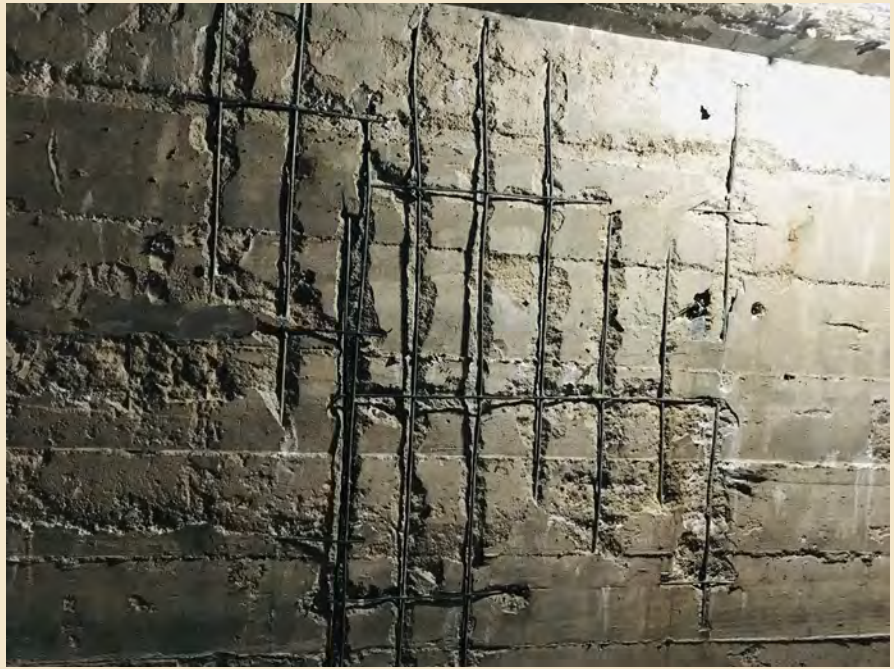
Figure 7.2

The three-inch thick concrete roof deck had very little coverage depth over the metal mesh reinforcement. The structural integrity of the slab, and the presence of water vapor in it are unknown. Additional investigation is required.

#### *Deterioration of concrete roof slab and reinforcement (Figure 7.2)*

Extensive and consistent spalling, efflorescence and rust staining at the underside of the existing roof slab is indicative of the passage of water vapor through the roof slab, inadequate coverage of the wire mesh slab reinforcement, and potential instability of the roof construction. The exposed wire mesh may, in some locations, be an original install condition, likely the result of the combination of inadequate concrete mix, minimal coverage depth over the wire mesh, and air pockets within the concrete pour. The slab appears to be sagging in places.

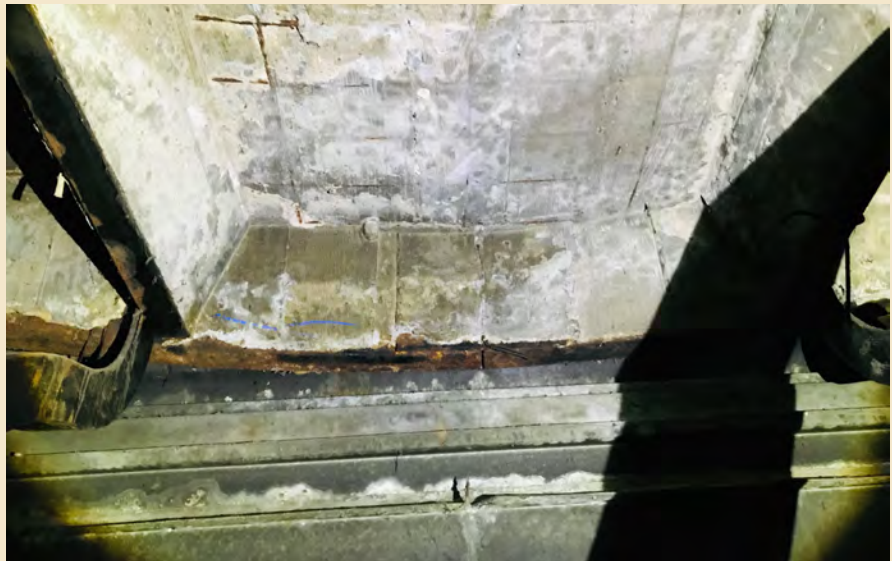
Figure 7.3

Extensive efflorescence and water staining at the concrete roof deck and rusting at the structural steel support members of the roof spire may have compromised the integrity of the structure. Additional investigation is required.

*Substantial water intrusion and insufficient structure at copper roof spire (Figure 7.3, previous page)*

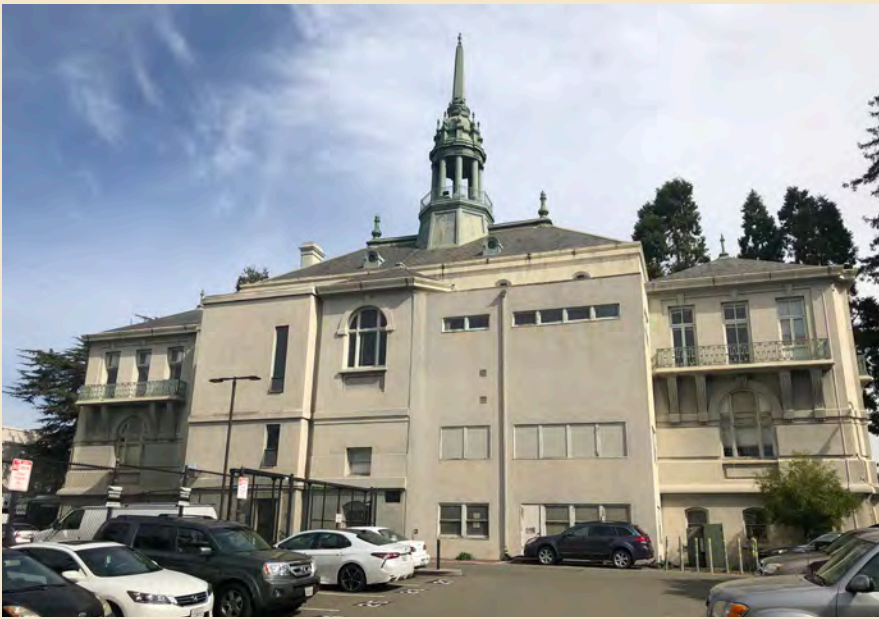
Figure 7.4  
The original stair tower of the rear (west) façade has been engulfed by two additions, rendering the historic façade unreadable.

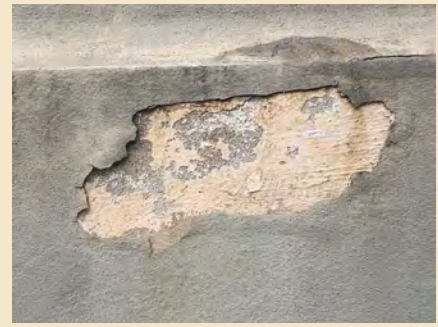
Figure 7.5  
At this location on the east elevation, exterior wall coatings have peeled away indicating the many layer of coatings over time.

*Buildup of exterior wall renders and coatings over time (building wide) may require replacement (Figure 7.5)*

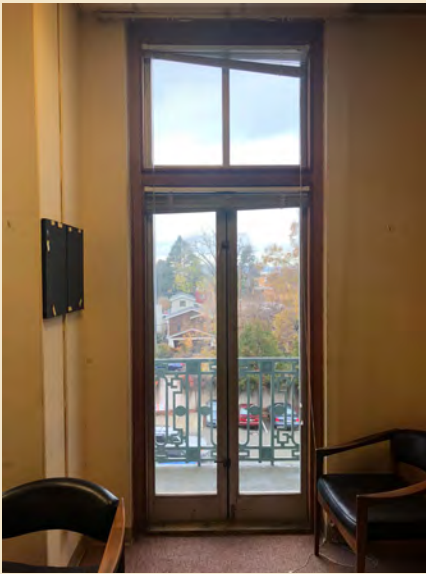
Figure 7.8  
At the second floor south wing, the double hung wood windows have been replaced with inappropriate aluminum casement windows.
