**BERKELEY CITY COUNCIL FACILITIES, INFRASTRUCTURE,
TRANSPORTATION, ENVIRONMENT & SUSTAINABILITY COMMITTEE
SPECIAL MEETING**

**Wednesday, September 3, 2025
2:00 PM**

2. Recreation and Community Facility Improvement Measures

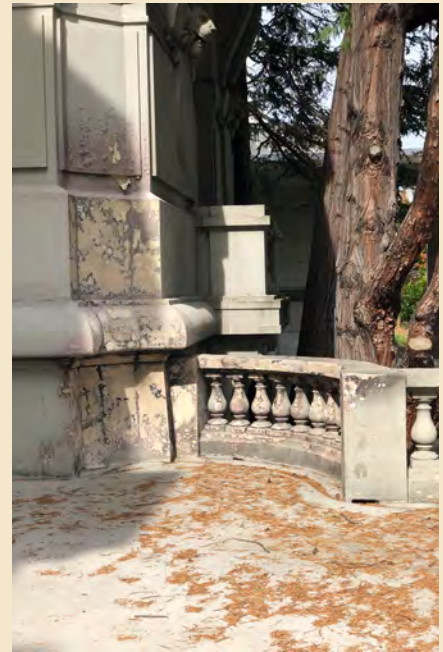
Figure 7.9  
A fire started at the north alcove of the entry terrace has damaged the building's exterior finishes.

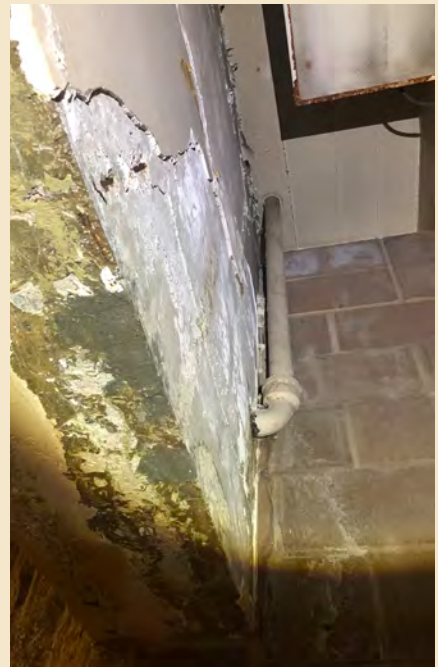
Figure 7.12  
Excessive water infiltration at this overhead concrete beam in the basement has caused ferric jacking at the rebar and widespread efflorescence.

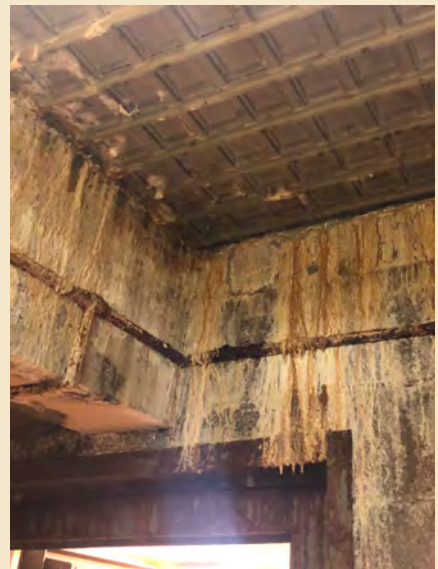
Figure 7.13  
The original sidewalk lites of the front entry terrace were poorly infilled with concrete. Salt laden water infiltration has built up over time on the concrete surfaces and electrical conduit below the entry terrace, creating a dangerous condition.

***Recommendations (spaces below concrete entry terrace)***

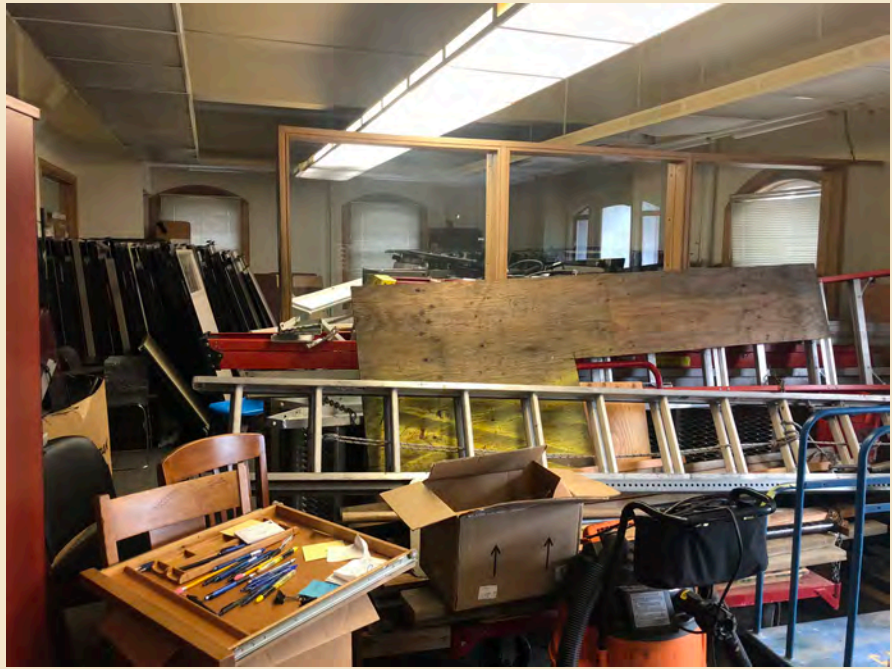
Figure 7.14  
The basement space has been divided into many spaces, are filled with furniture and debris, are dimly lit, and difficult to navigate. All debris and storage should be removed, and contemporary construction removed such that a proper condition survey can be conducted.

The primary space of the basement is in fair condition. The original spaces are now substantially divided up and generally contain only contemporary building finishes. The spaces are cluttered with furniture and debris, are poorly lit and are difficult to navigate. *(Figure 7.14)*

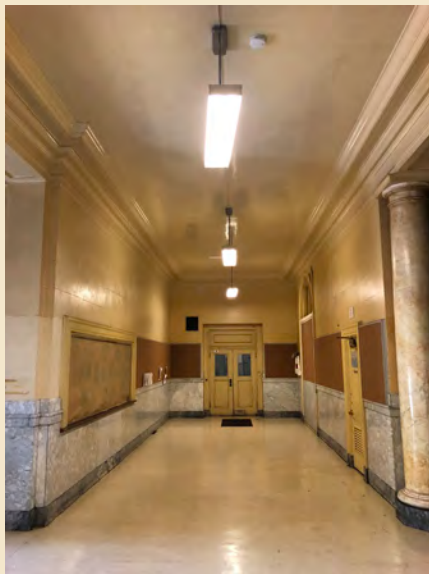
The spaces in the main entry and corridor are generally in good to fair condition. Modifications made over time alter the appearance and feel of the space. Further study of these deficiencies is included in the recommendations; however, it should be noted that any analysis or treatment of these materials should be conducted by a professional conservator. (See Figure 7.15)

Figure 7.15  
Although the original layout and materials of the main entry corridor remain, a number of alterations have altered the appearance and feeling of the space.

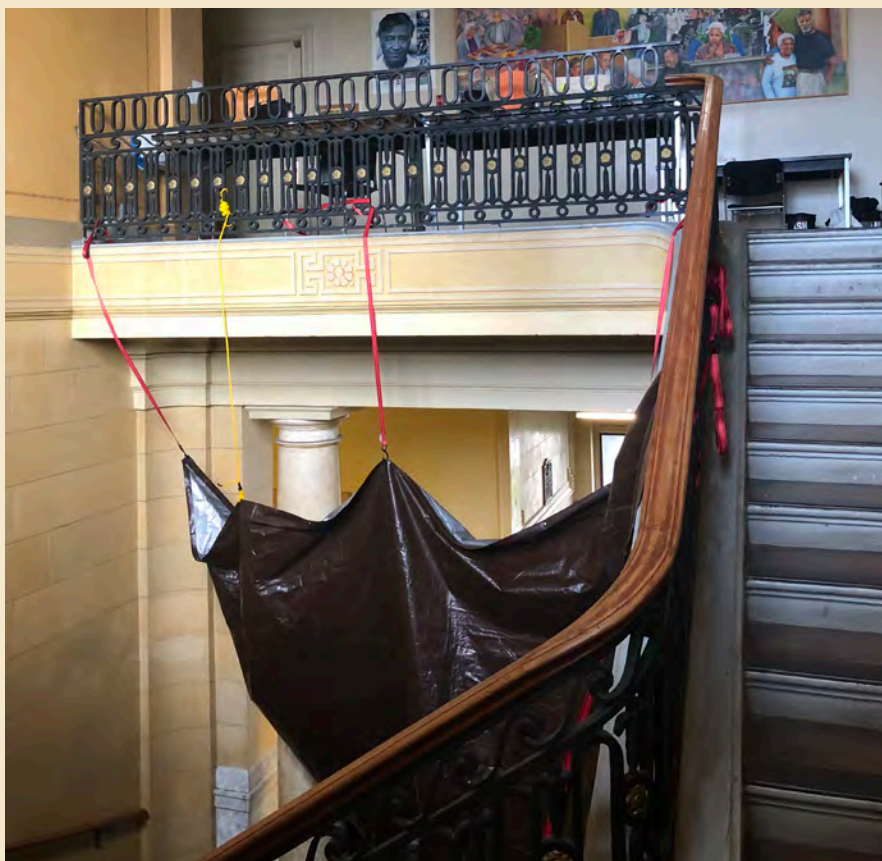
Figure 7.16  
The double height space with stairs below at the main staircase will make access to the ceiling and original pendant light fixture difficult.

The centrally located staircase is in fair condition. Wear and tear, accumulation of soil and grime, and inappropriate repairs have compromised the integrity of this significant space. Further study of these deficiencies is included in the recommendations; however, it should be noted that any analysis or treatment of these materials should be conducted by a professional conservator. Given the height and configuration of this space, access to the ceiling and pendant light fixture will require additional consideration. (Figure 7.16)

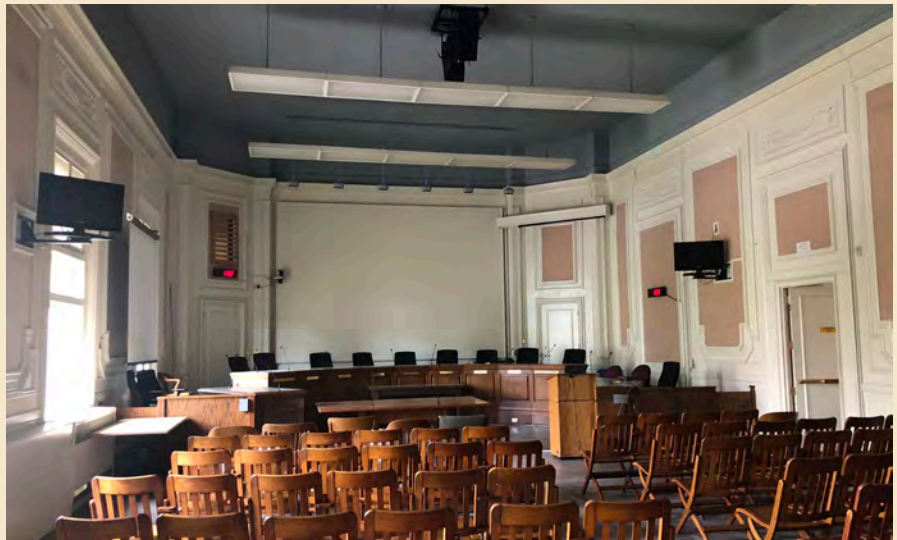
Figure 7.21

The second floor council chambers have been modified over time; the room no longer contains the historic coffered ceiling or lighting fixtures, and has new acoustical wall paneling and new flooring.

The Council Chamber is a character defining space that has been modified numerous times over the years. It is in fair condition. Further study of these deficiencies is included in the recommendations; however, it should be noted that any analysis or treatment of these materials should be conducted by a professional conservator. (See Figure 7.21)

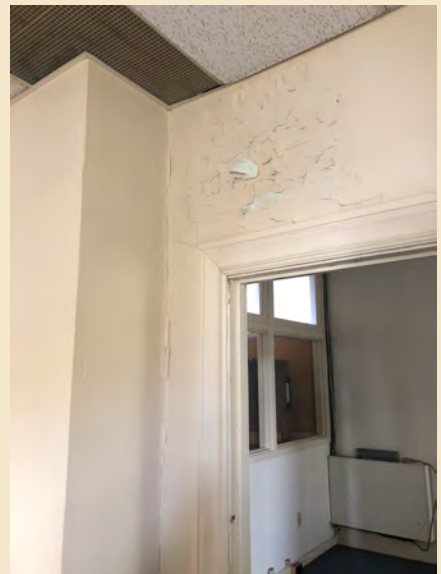
Figure 7.22

*Evidence of substantial water damage appears to be directly under the intersection of the north wing and central core of the building (Figure 7.22)*

Many of the finishes at the south wall of the north wing show evidence of water intrusion. Additional investigation is required.

Perform selective demolition of carpeting as a part of larger finishes survey to determine original flooring below. The presence of scored concrete flooring in the adjacent secondary stairwell may be indicative of original flooring.

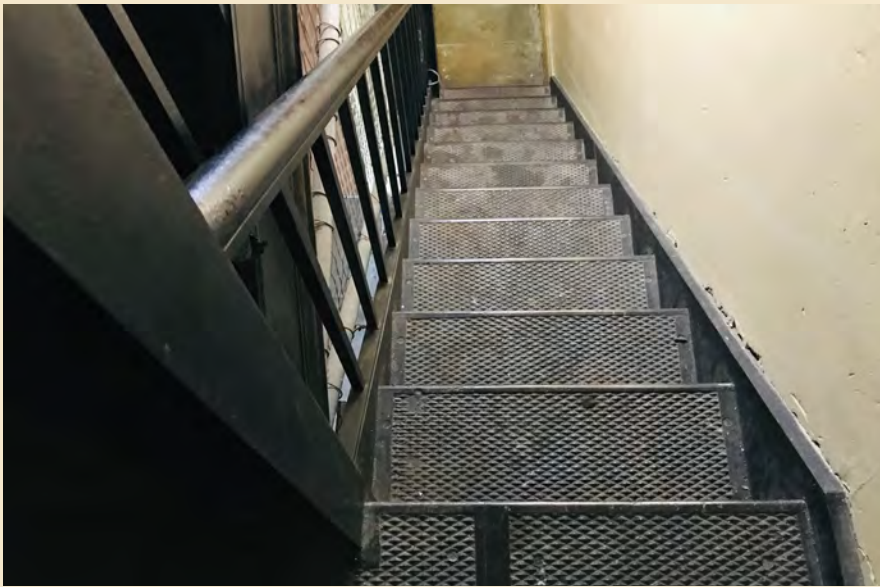
Figure 7.24  
The cast iron stair to the second floor is original but does not meet current building code standards.
